**ORCHARD VILLAS CONDO
UOA
APEX, NC**

**DATE:
JULY 29, 2024**

**RESERVE STUDY
UPDATE with Site
Inspection**

GILES & FLYTHE
ENGINEERS

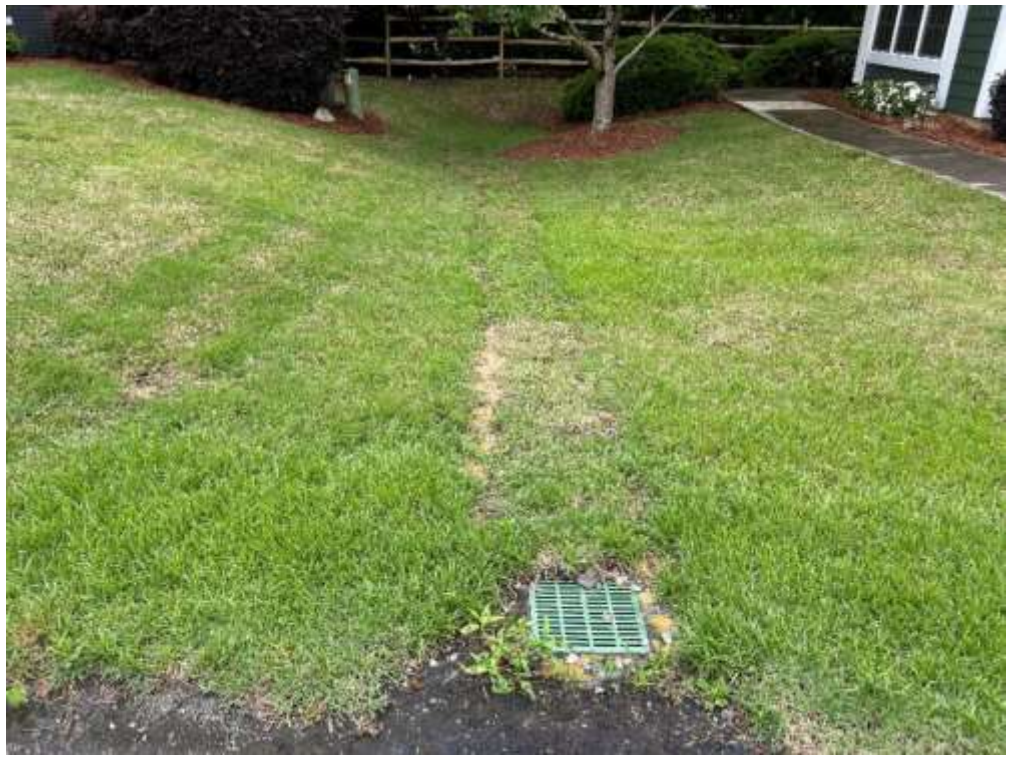
Photo No.
5

Site drainage between
condominiums

We have allocated funds to repair the drainage systems on a 5-year cycle beginning in 2026. Repairs will likely include retrenching of swales to improve flow, adding rip rap or vegetation to stabilize exposed or steep areas, extending gutter downspouts to underground systems, repairing erosion concerns, repairing gabion type retaining walls, installing french drains or other types of minor drainage systems.

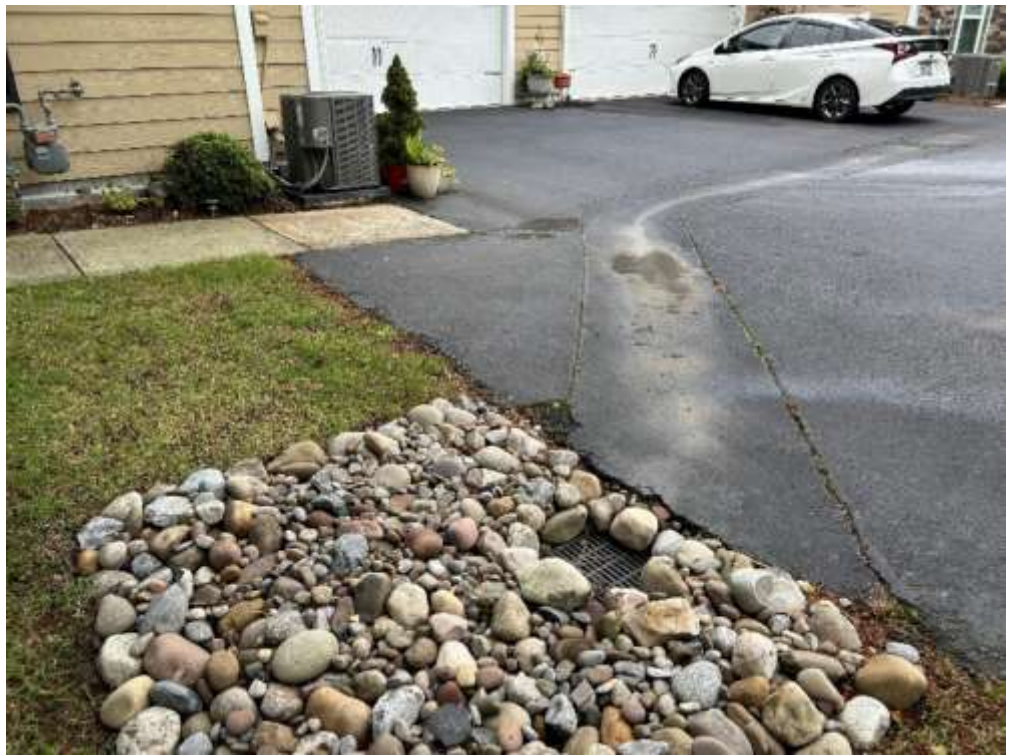
Photo No.
6

Site drainage adjacent to
asphalt driveway

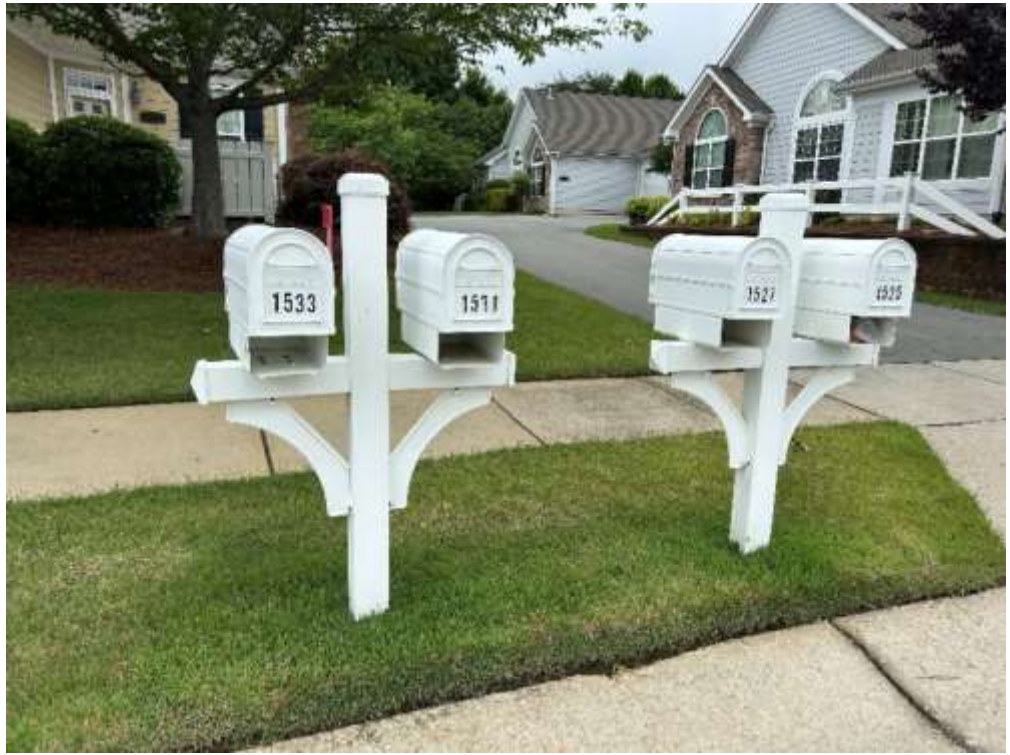
Photo No.
9

Mailboxes are installed on vinyl posts at each building in the community. The mailboxes generally appeared to be in good condition and have an expected useful life of approximately 20 years. We have allocated funds to replace them every 20 years beginning in 2034.

Typical mailboxes on site

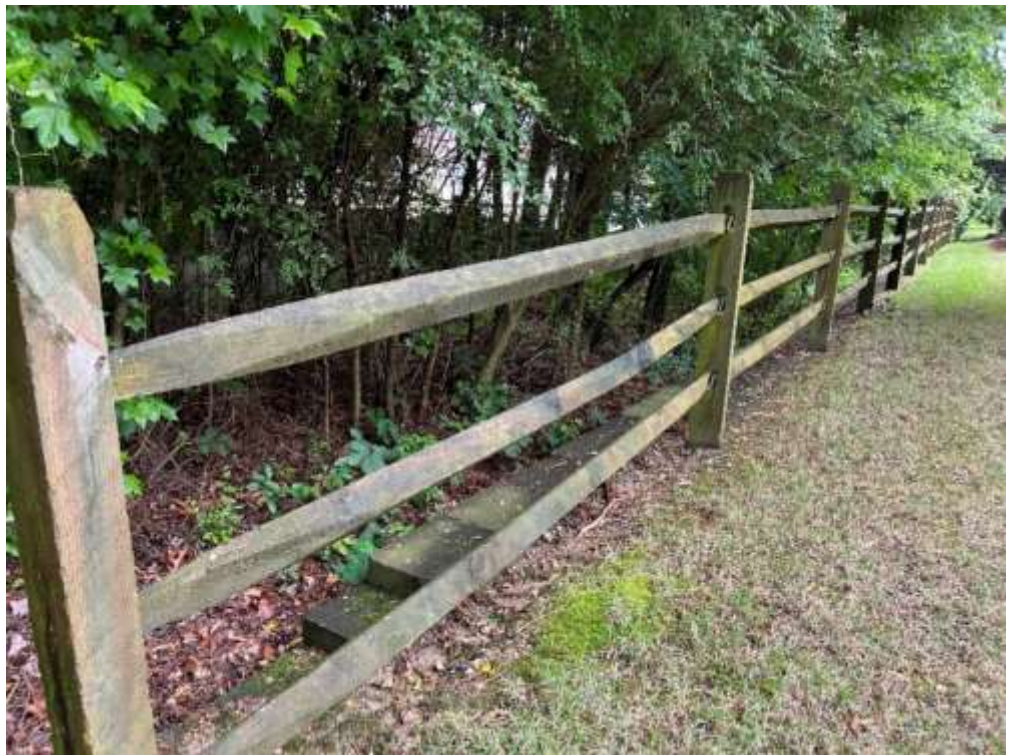
Photo No.
10

Split rail wood fencing is installed above a retaining wall along the southern border of the community. The wood fencing generally appeared to be in good to fair condition. We have assumed minor repairs of the fencing would be funded from an annual maintenance budget. We anticipate the wood fencing to have an expected useful life of approximately 15-20 years and have allocated funds for full replacement every 15 years beginning in 2029.

Split rail wood fence at rear of condominiums

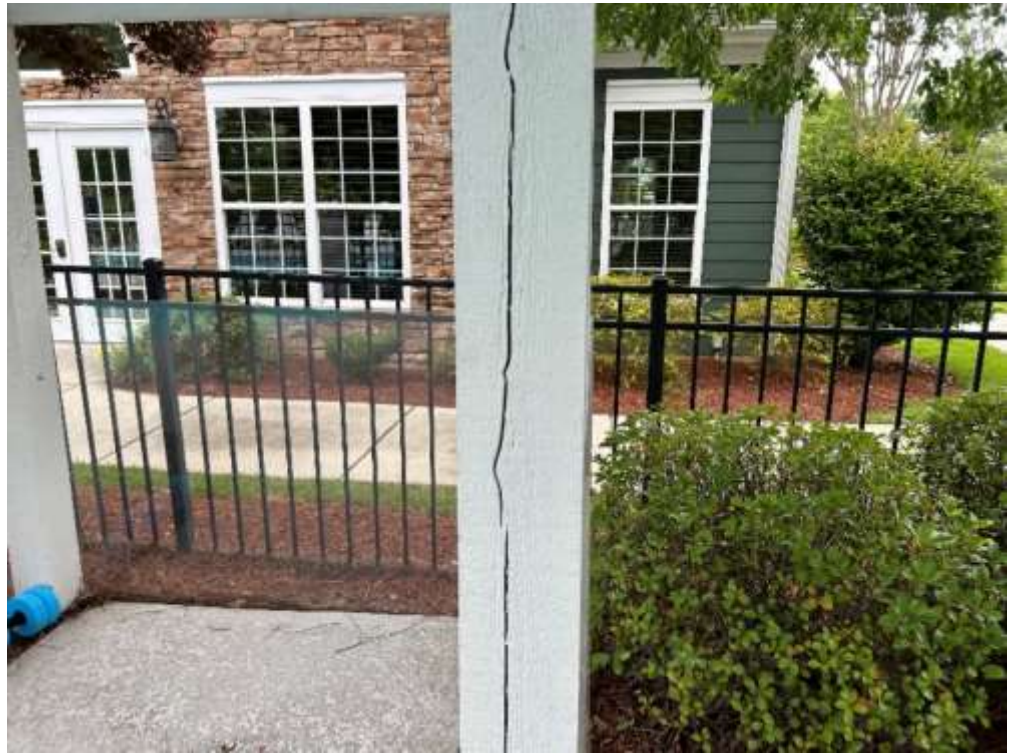
Photo No.
11

Anodized aluminum fence surrounds the pool area. The fencing appeared to be in generally good condition. We assume minor repairs to the fencing would be funded from an annual maintenance budget as needed. Assuming a useful life of approximately 40 years, we have included funds to replace the fence in 2048.

Aluminum fence and
pergola structure at pool

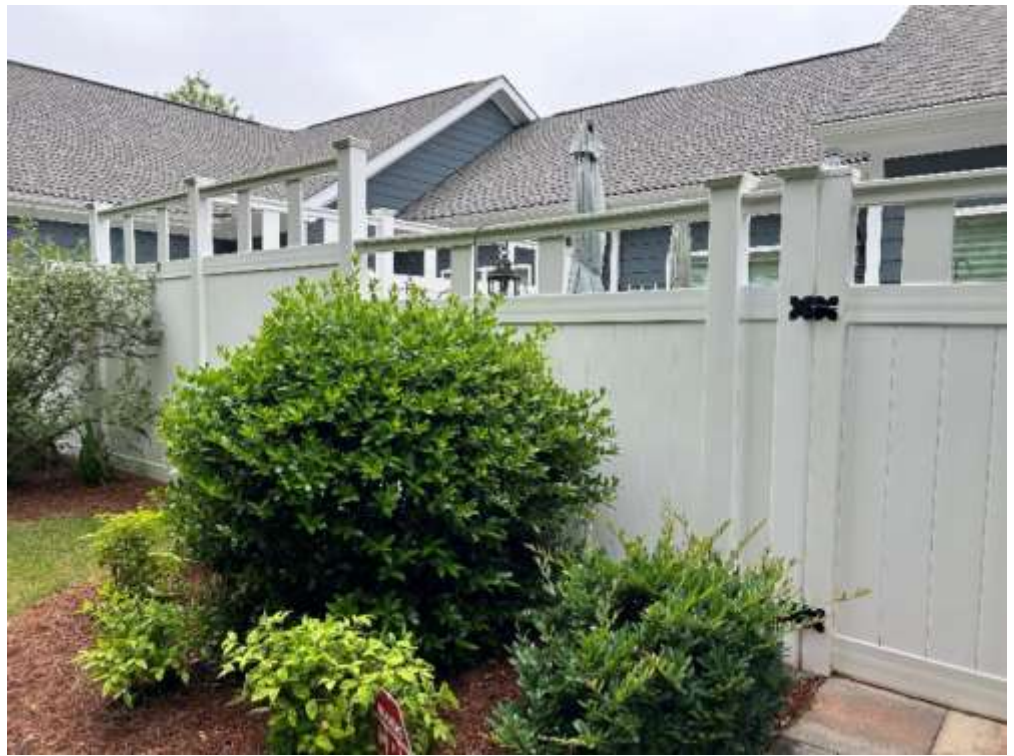
Photo No.
12

Vinyl fencing at rear of
condominiums

Select units include vinyl privacy fencing installed behind the buildings. Vinyl fencing is also installed in common areas along the top of sections of retaining walls in the community. The vinyl fencing will require periodic minor repairs and cleaning throughout the term which we have assumed would be funded from an annual maintenance budget. Additionally, we have allocated funds for replacing vinyl fencing on a 25-year cycle beginning in 2038.

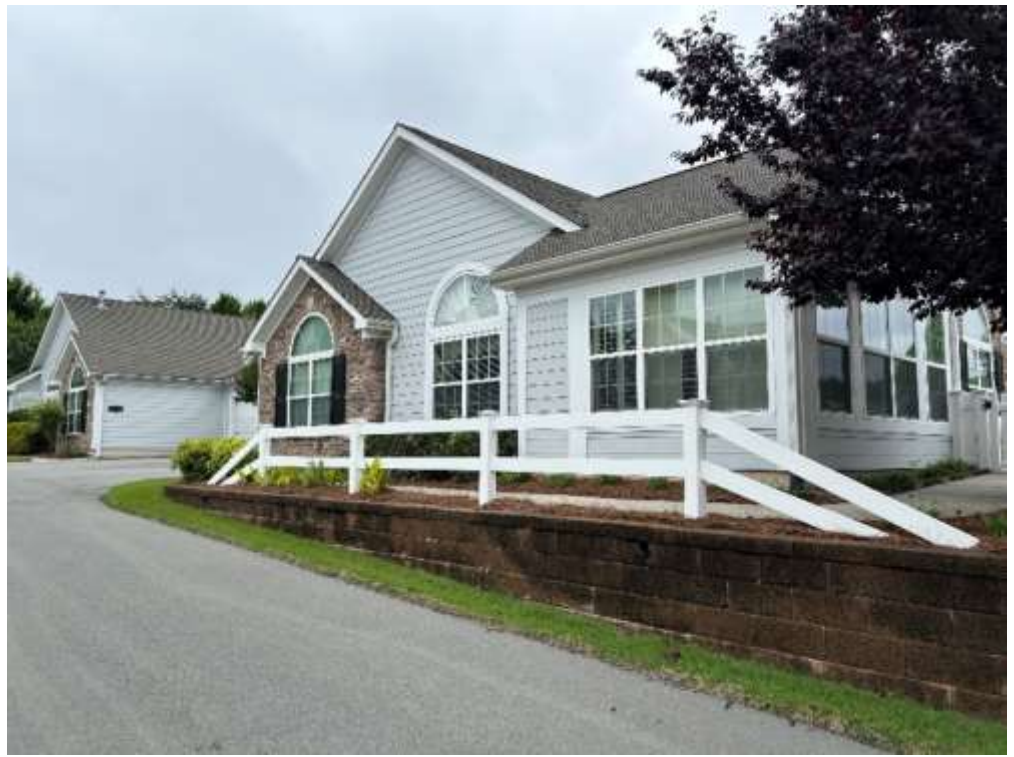
Photo No.
13

Vinyl fencing

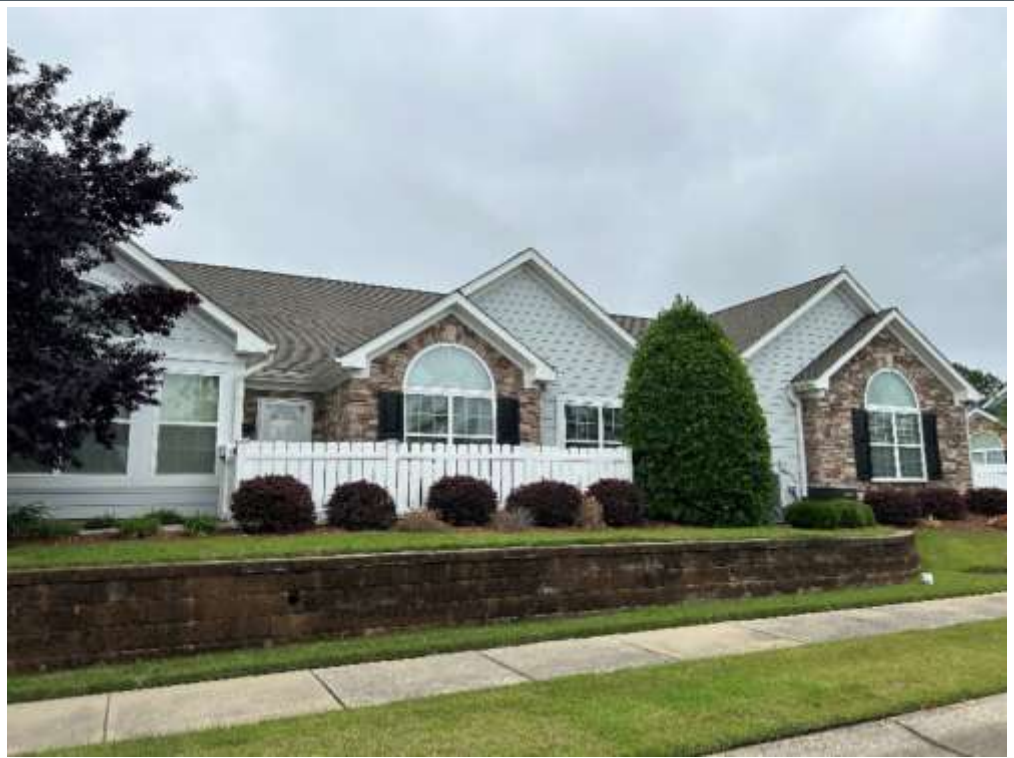
Photo No.
14

Vinyl fencing and
retaining wall

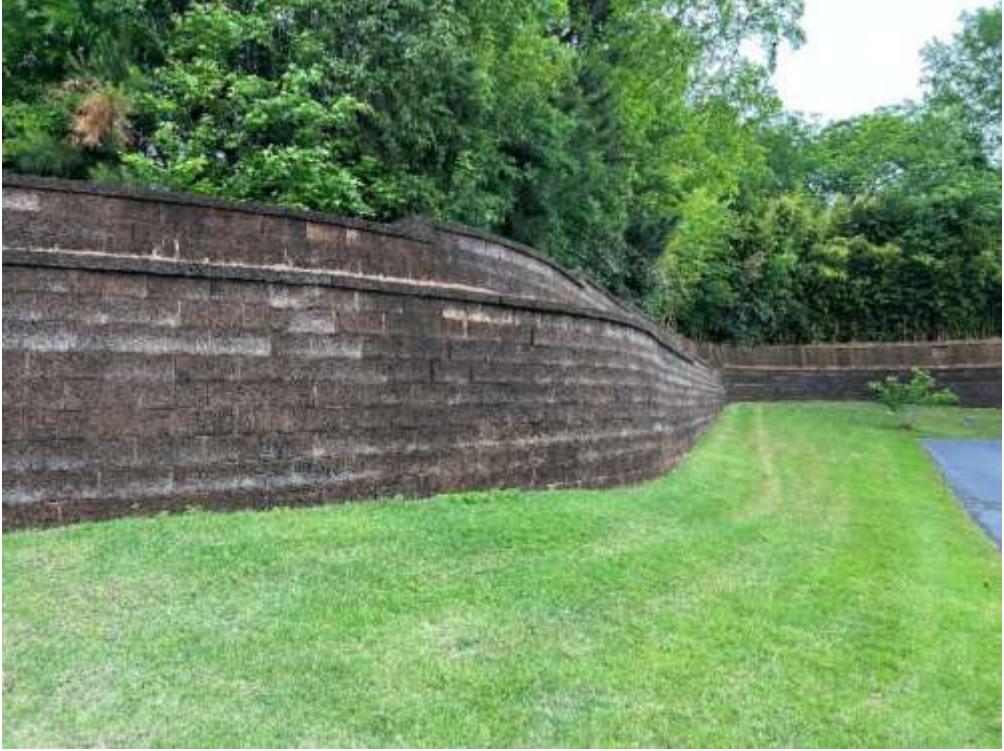
<p>Photo No. 15</p>

<p>Description</p> <p>General view of retaining wall</p>

Segmental block retaining walls with geo-grid reinforcement are installed in several areas of the community. This type of retaining wall system has an expected useful life beyond the term of this study. However, minor repairs to cap blocks and drainage systems associated with the wall will likely be required in the interim and have been included in the drainage system repairs mentioned earlier in this section. Considering the substantial amount of retaining walls, we have provided an allocation of funds at the end of the term to begin to prepare for long term substantial repair expenses.

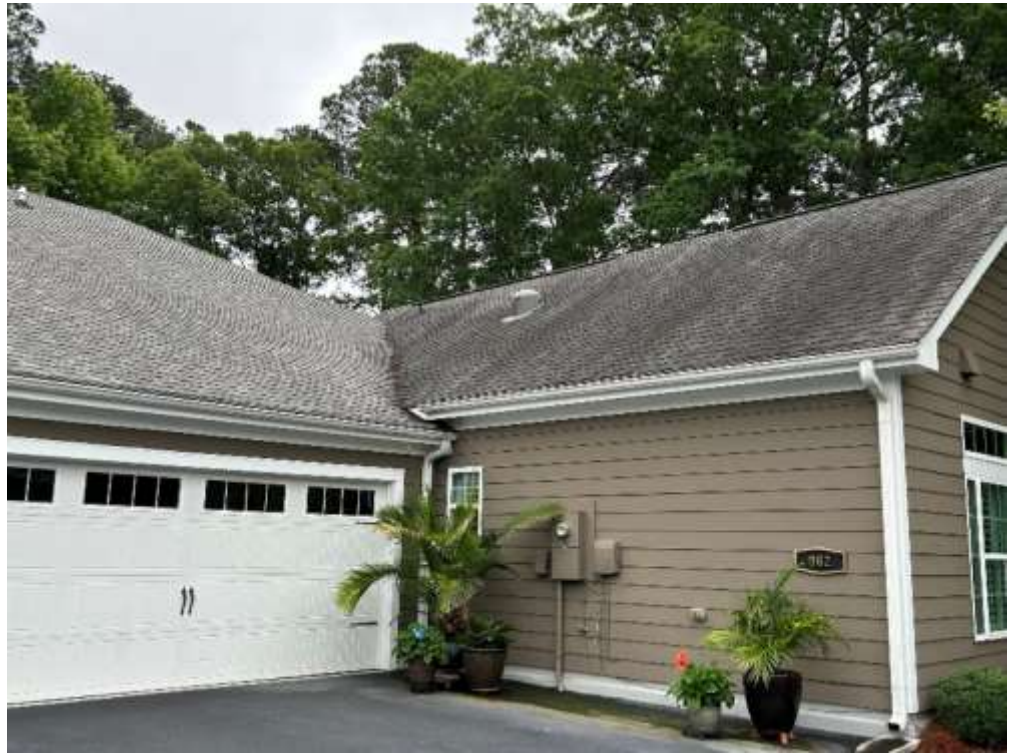
Photo No.
17

The predominant pitched roof surfaces over the buildings are covered in asphaltic fiberglass, architectural grade shingles. Roof surfacing is applied over roof sheathing, and appears to be in good condition. We are unaware of any concerns with current or previous roof leaks. Minor roofing improvements over term will likely include replacing vent boots, flashing and drip edge repairs, and gutter repairs. We have assumed these types of minor repairs would be funded from an annual maintenance budget.

Minor deterioration and
discoloration on roofs

The architectural-grade asphaltic shingles on the pitched roof surfaces typically have an expected useful life of approximately 20-25 years, assuming minor repairs are completed as needed in the interim. We strongly recommend that any re-roofing project closely follow procedures outlined by the National Roofing Contractors Association's *Roofing and Waterproofing Manual*. A re-roofing sequence should include removal of the existing roofing material, replacement of any inadequate roof sheathing, replacement of any damaged flashing, and replacement of drip edge components.

We have allocated funds to replace the roofs on the buildings in the community in three phases based on dates of original construction and previous re-roofing. The first phase of replacement is anticipated to begin in 2029 with the buildings constructed between 2008 and 2011 (includes clubhouse). The second phase will begin in 2033 with the buildings constructed between 2013 and 2015. The third phase will begin in 2041 with the buildings that were recently re-roofed in 2021. Refer to the table below for a list of specific buildings included in each roofing phases.

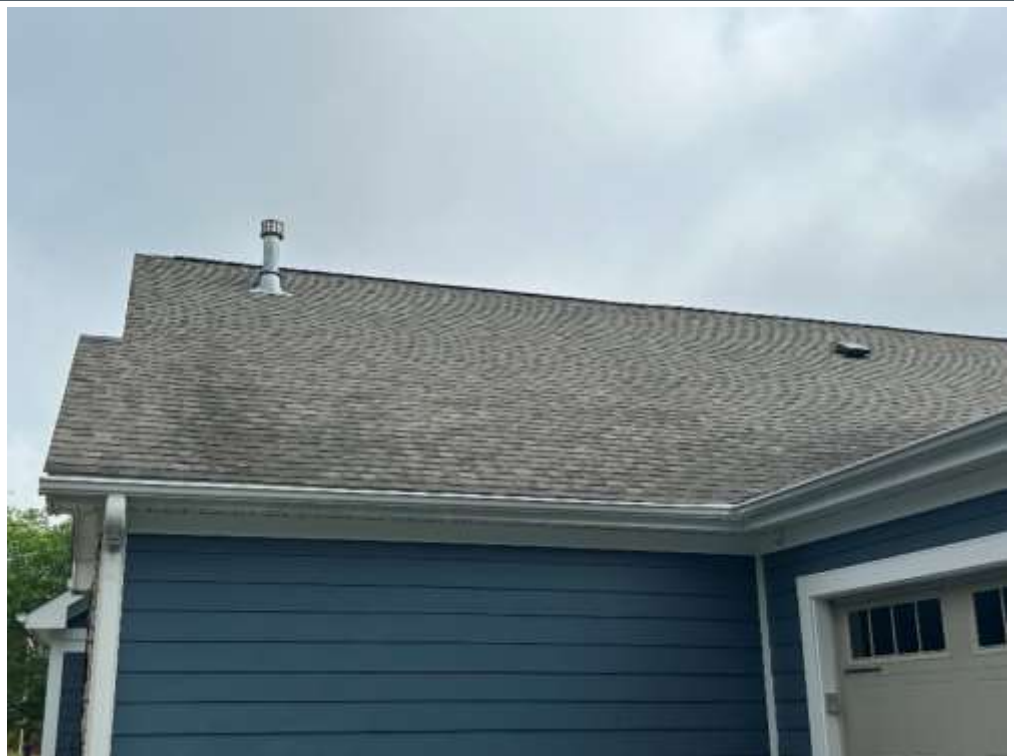
Photo No.
18

Discoloration and
texture loss on roofs

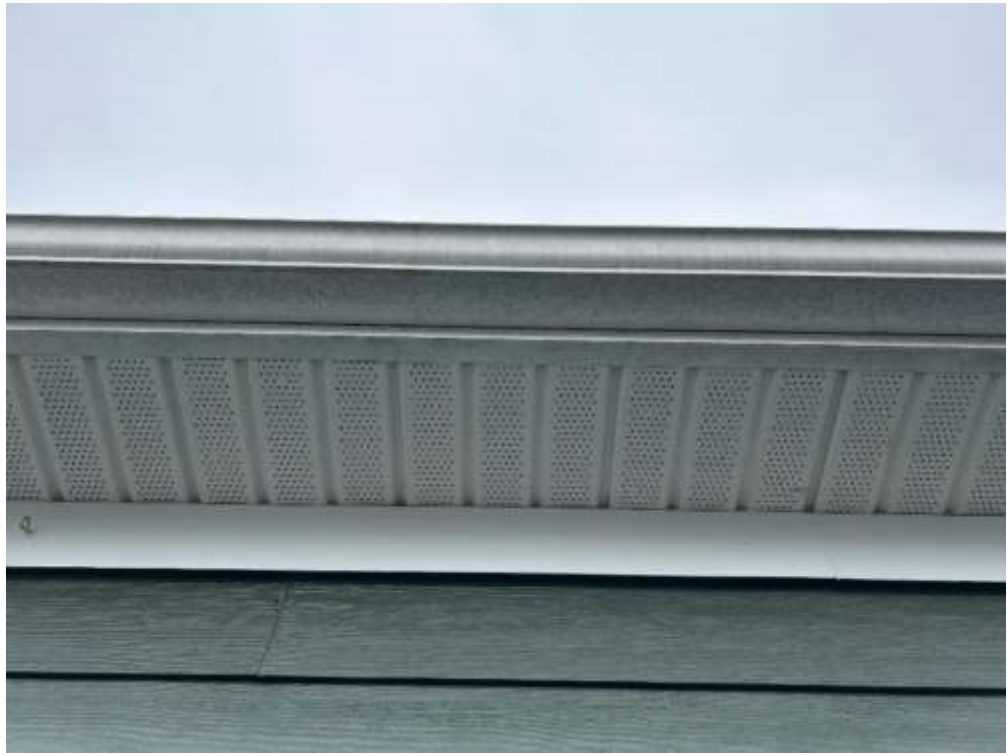
Photo No.
19

Paintable trim and gutters

The buildings in the community are of wood framed construction and are primarily clad in fiber cement siding and trim with sections of brick and stone veneer. The exterior surfaces generally appeared to be in good condition, however they will require periodic painting and minor repairs. The buildings were painted in two phases in 2018 and 2022. We have allocated funds to paint the fiber cement siding and trim components and make minor repairs in the same two phases on a 7-year cycle, with Phase 1 beginning in 2025 and Phase 2 beginning in 2029.

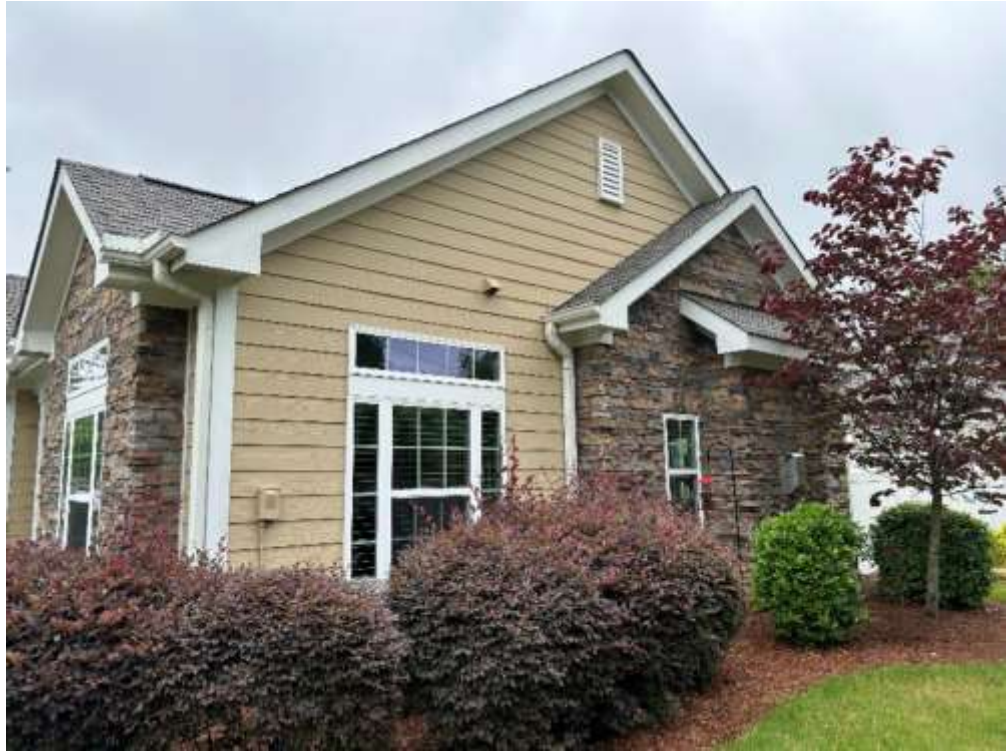
Photo No.
20

Paintable trim and siding on condominium units

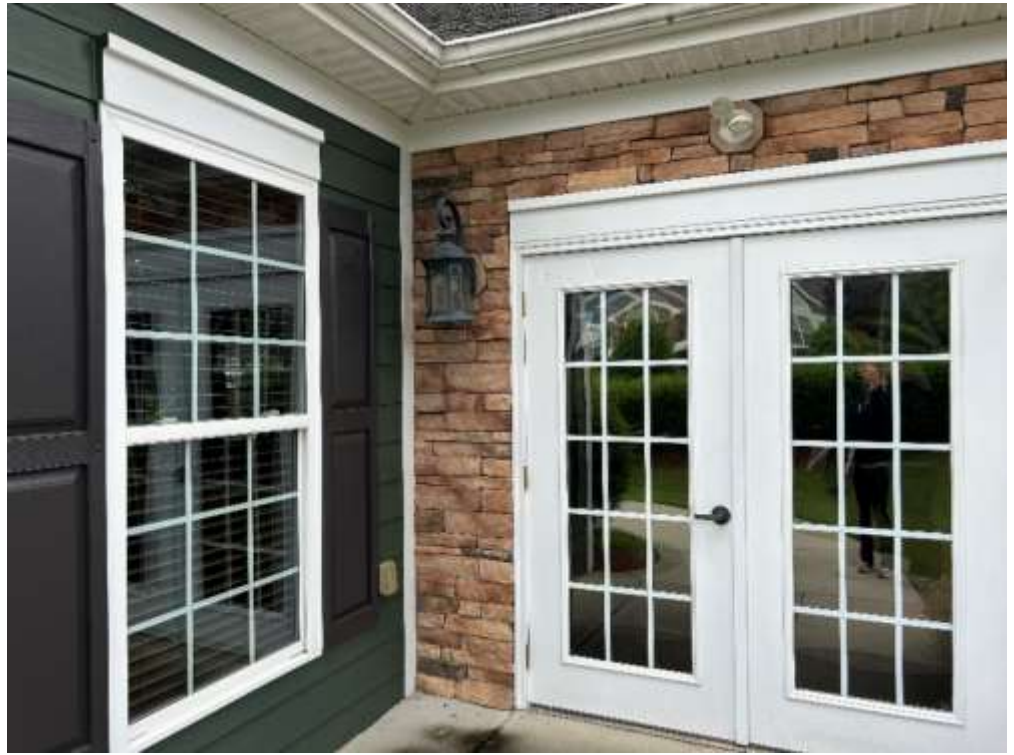
Photo No.
21

Clubhouse door and window

The clubhouse building includes fiberglass doors and vinyl windows. The doors and windows have an expected useful life of approximately 20 to 30 years and we have allocated funds for their replacement in 2038. We have assumed that film replacement on the Palladian windows would be funded from the annual maintenance budget. Note that per the governing documents, the association is not responsible for replacing the doors and windows on the condominium buildings.

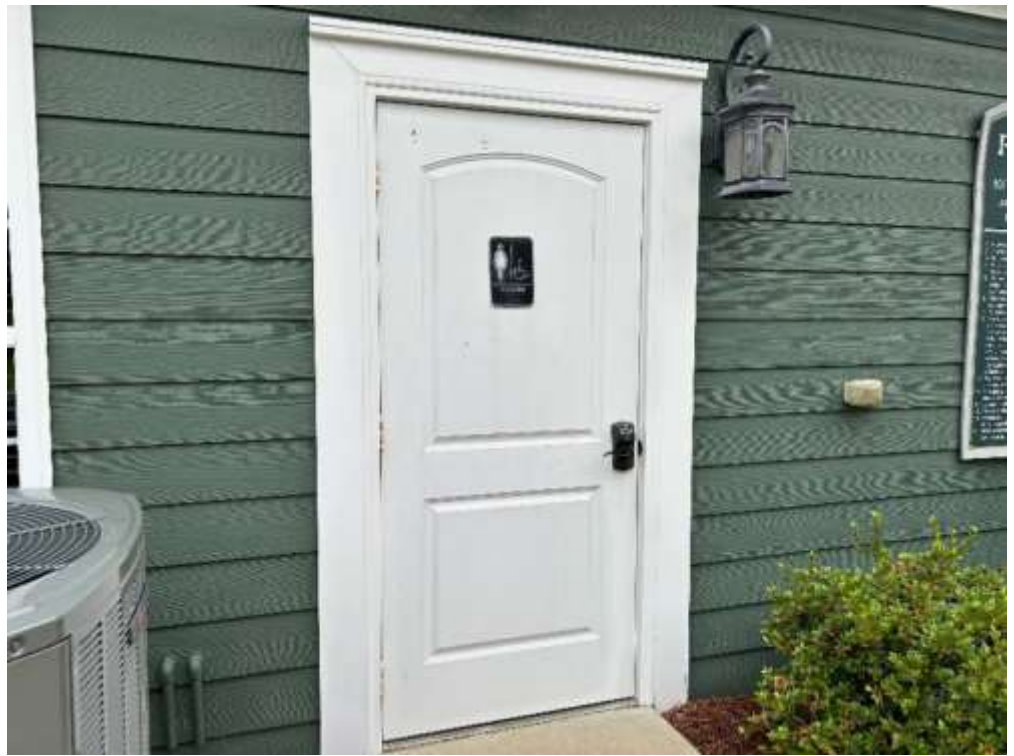
Photo No.
22

Clubhouse door

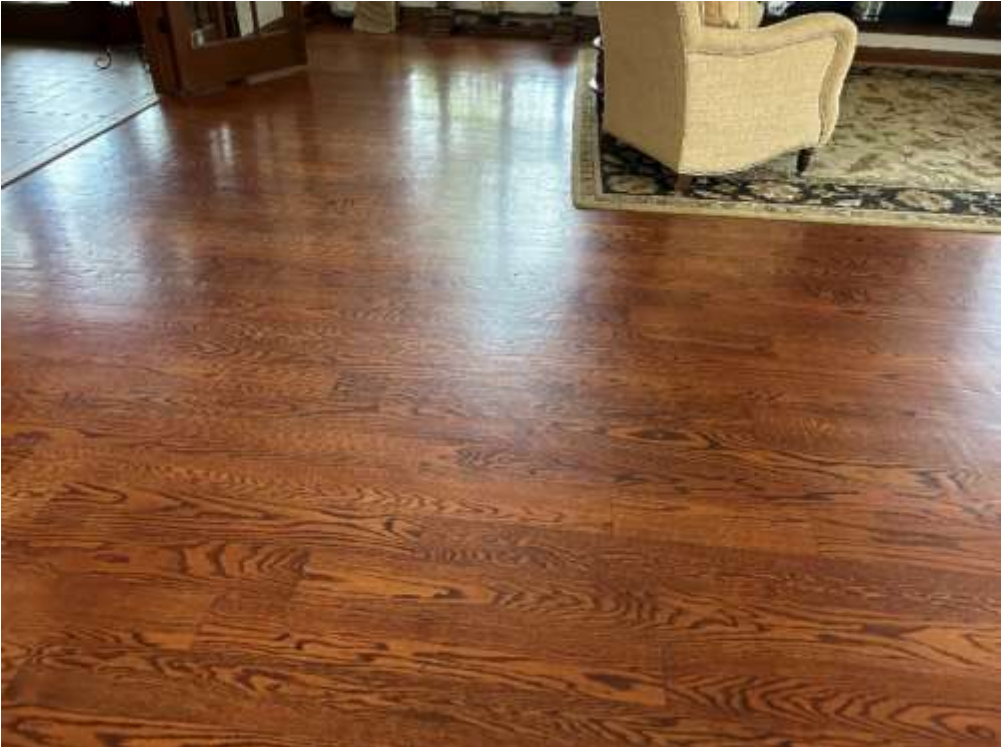
<p>Photo No. 24</p>

<p>Description</p> <p>Clubhouse hardwood flooring</p>

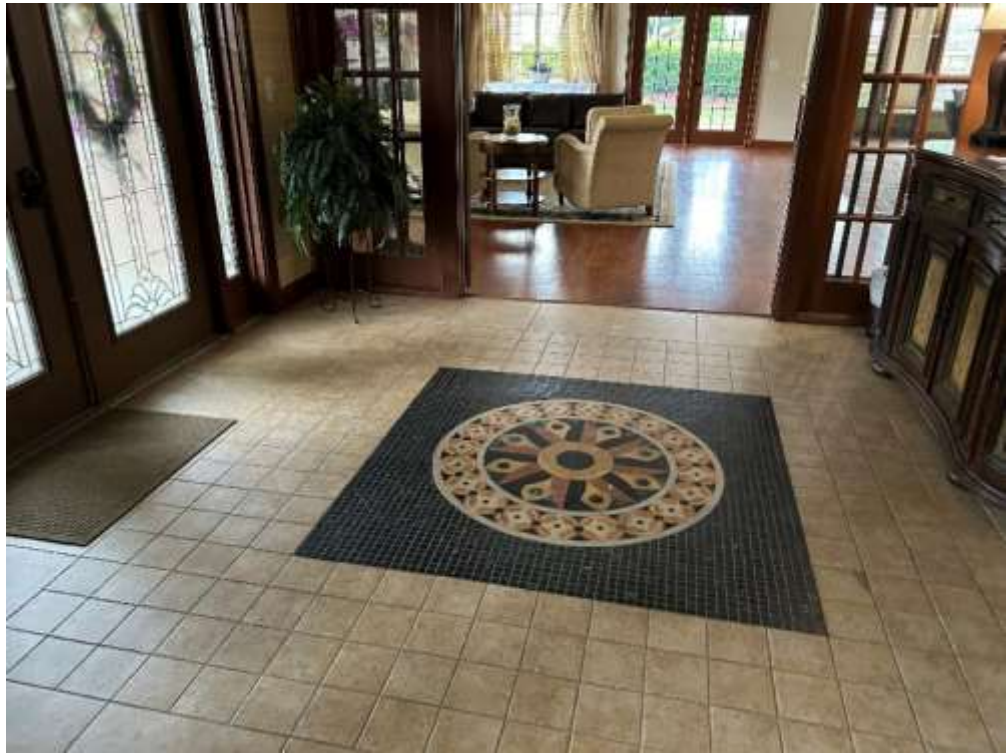
Photo No.
25

Description
Clubhouse entry tile

15-year cycle beginning in 2038. We have also allocated funds to replace the tile flooring at the clubhouse entry and on the floors and walls of the restrooms on a 25-year cycle beginning in 2033.

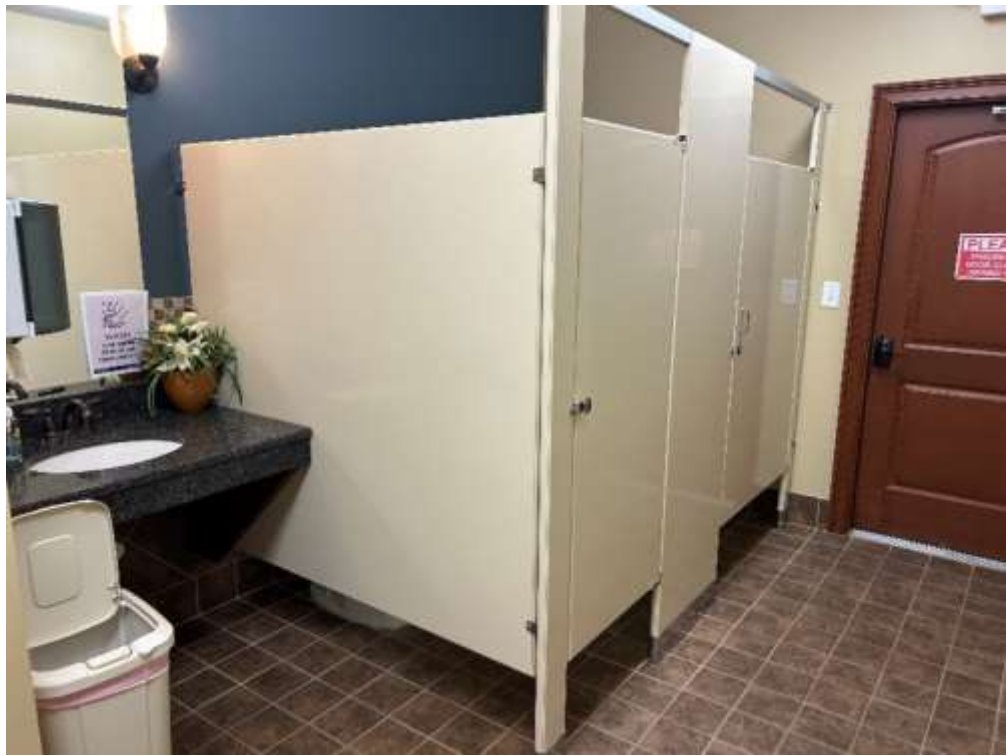
Photo No.
26

Description
Clubhouse restroom tile
and partitions

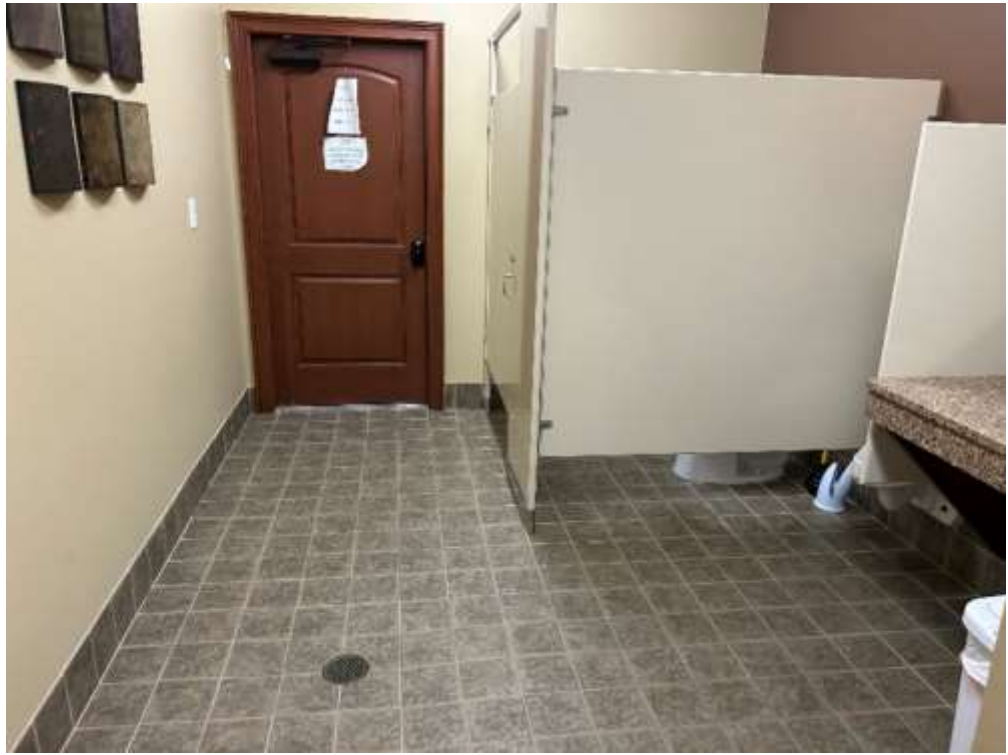
Photo No.
27

The clubhouse includes men's and women's restrooms with toilet stalls, partitions and a sink with granite countertops. The fixtures in the bathrooms appeared to be in good condition and have an expected useful life of approximately 15 to 25 years depending on use. We have allocated funds to replace/refurbish the restrooms on a 25-year cycle beginning in 2030.

Description
Clubhouse restroom

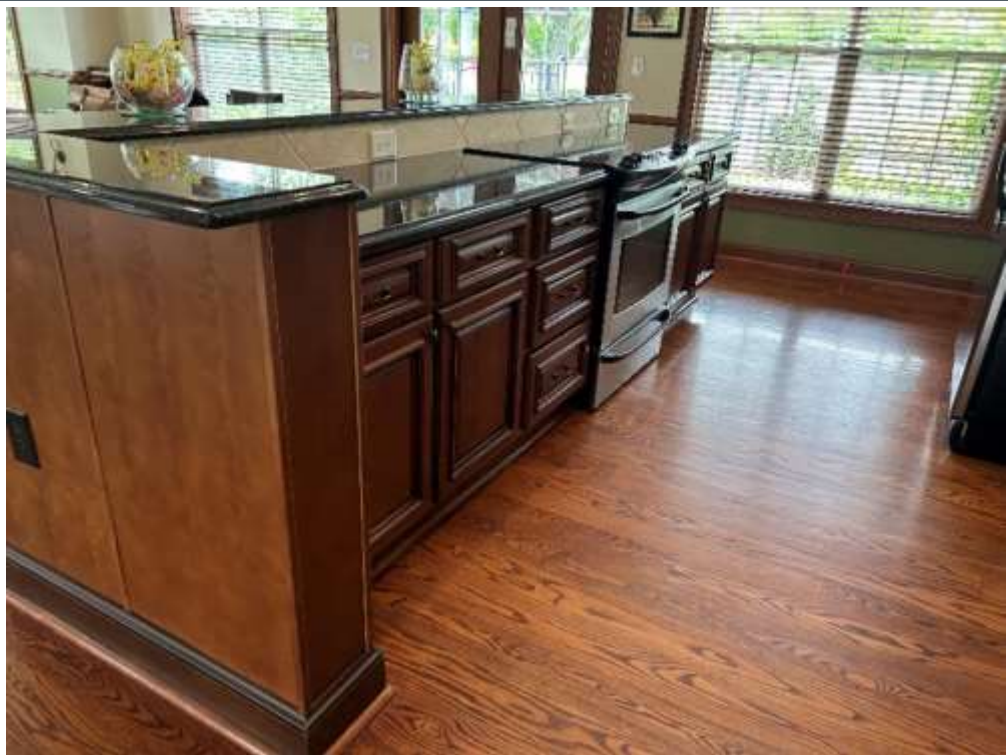
Photo No.
28

Description
Clubhouse kitchen
cabinets and countertops

The clubhouse kitchen includes wood cabinets, granite counter tops, a sink, stainless steel side by side refrigerator, smooth top range/stove, dishwasher and microwave. The kitchen cabinets and appliances generally appeared to be in good condition. We have provided an allocation of funds to replace appliances as needed on a 3-year cycle beginning in 2026 and to refurbish the kitchen cabinets/counters on a 25-year cycle beginning in 2030.

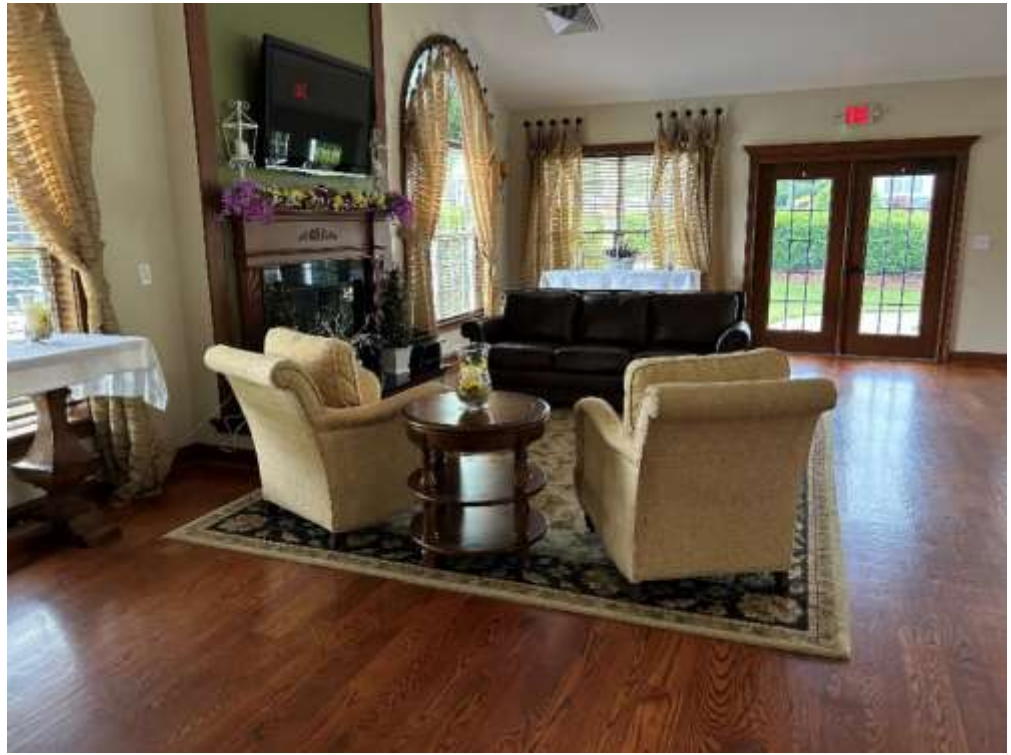
Photo No.
29

General view of
clubhouse furnishings

The clubhouse includes a great room with card tables, a pool table, upholstered furniture and several wood tables. The clubhouse also includes two furnished office spaces and a foyer with various artworks, rugs and furnishings. We have provided an allocation of funds on a 5-year cycle beginning in 2025 to replace portions of the interior furnishings as needed. We have provided a separate allocation of funds to replace the common area pool table every 20 years beginning in 2035.

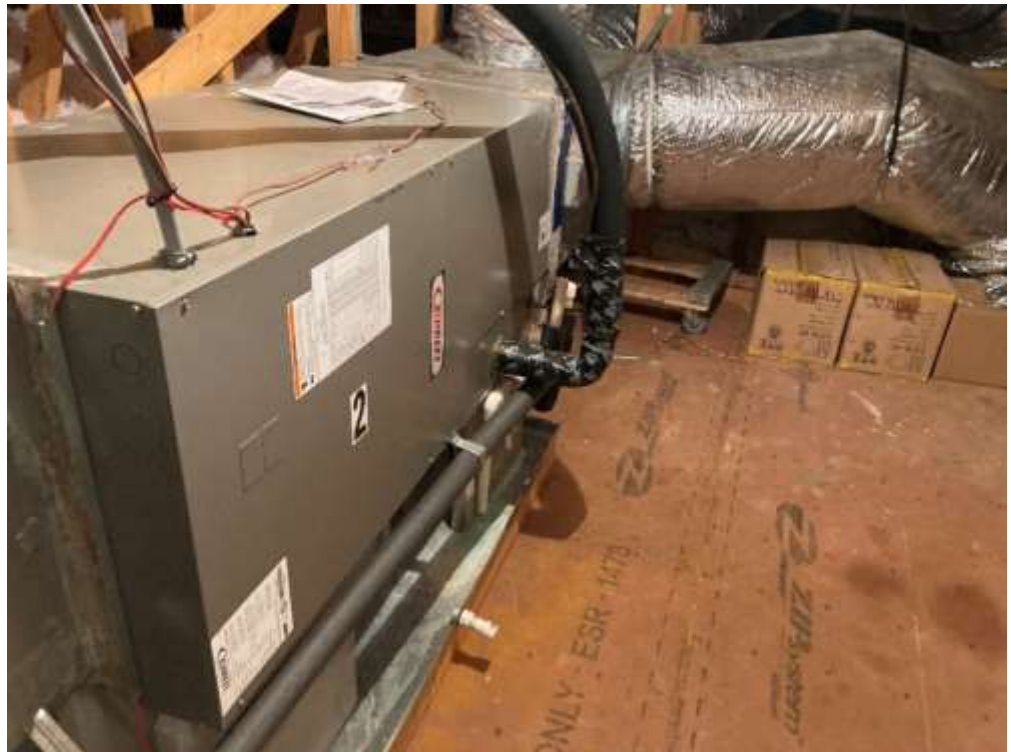
Photo No.
30

The clubhouse is served by a heating ventilation and air conditioning (HVAC) system that includes two 5-ton heat pumps with fan coil units located in the attic. A Lennox system (2016) services the main hall and a Trane system (2020) services the fitness room. HVAC equipment has an expected useful life of approximately 12-15 years and we have allocated fund to replace the Lennox system in 2028 and the Trane system in 2032.

Clubhouse HVAC

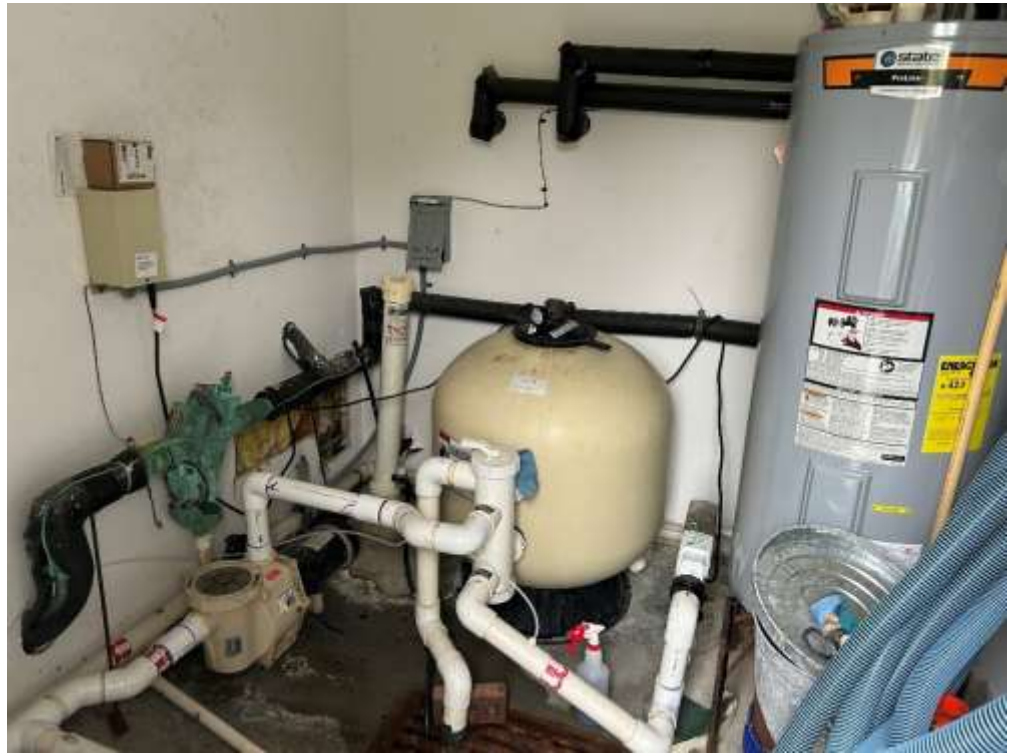
Photo No.
31

Water heater and pool
filtration equipment

The clubhouse includes a State ProLine 40-gallon electric water heater located in the pool pump room. We have allocated funds to replace the water heater on a 12-year cycle beginning in 2033. The clubhouse also includes a drinking water fountain that we have allocated funds to replace every 18 years beginning in 2026.

The pool system was converted to salt water in 2019. The pool pump and filtration equipment includes a 1.5 horsepower pump driven by an electric motor, a Pentair Intellichlor salt chlorine generator and a Triton II sand filter. These items are typically replaced as they fail, and we have provided funds to replace components of the pump and filtration system on a 3-year cycle beginning in 2025.

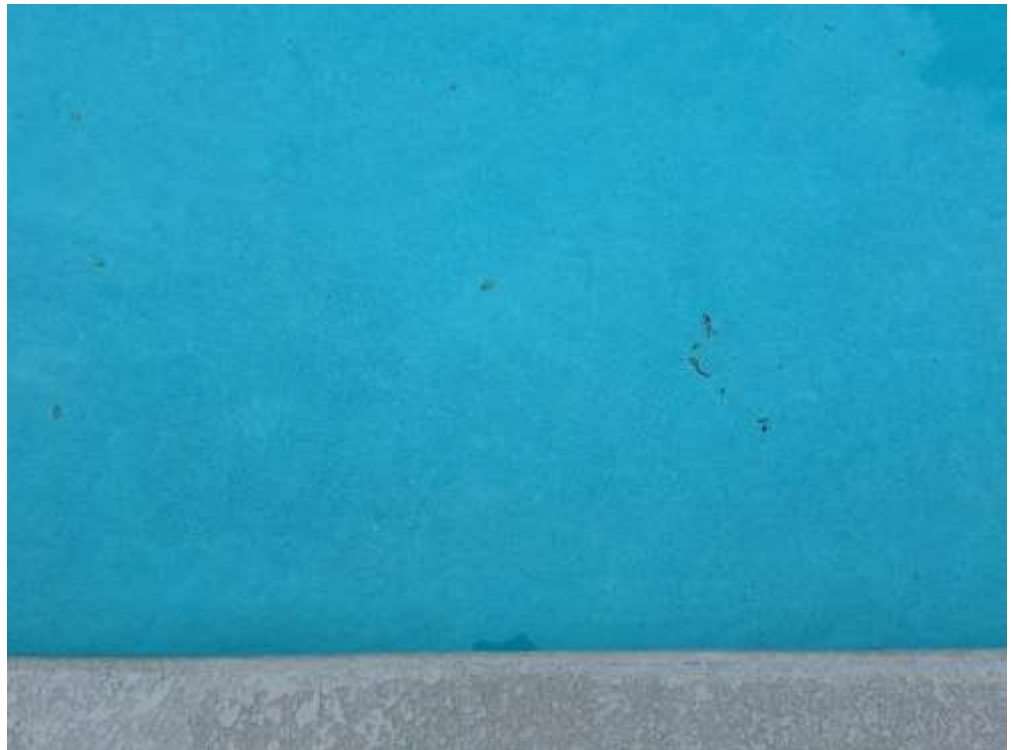
Photo No.
32

The swimming pool appears to have been constructed in conjunction with the clubhouse in 2008. Per documentation provided by the Association, the pool was resurfaced in 2019. The pool surface appeared to be in good condition during the inspection, noting that any observations were performed from above the water surface. Typically, pools should be drained, minor cracks repaired, and recoated (possibly quartz plaster) on an approximately 10–12-year cycle. We have budgeted funds for full resurfacing and tile repairs on a 12-year cycle beginning in 2031.

General view of pool
surface

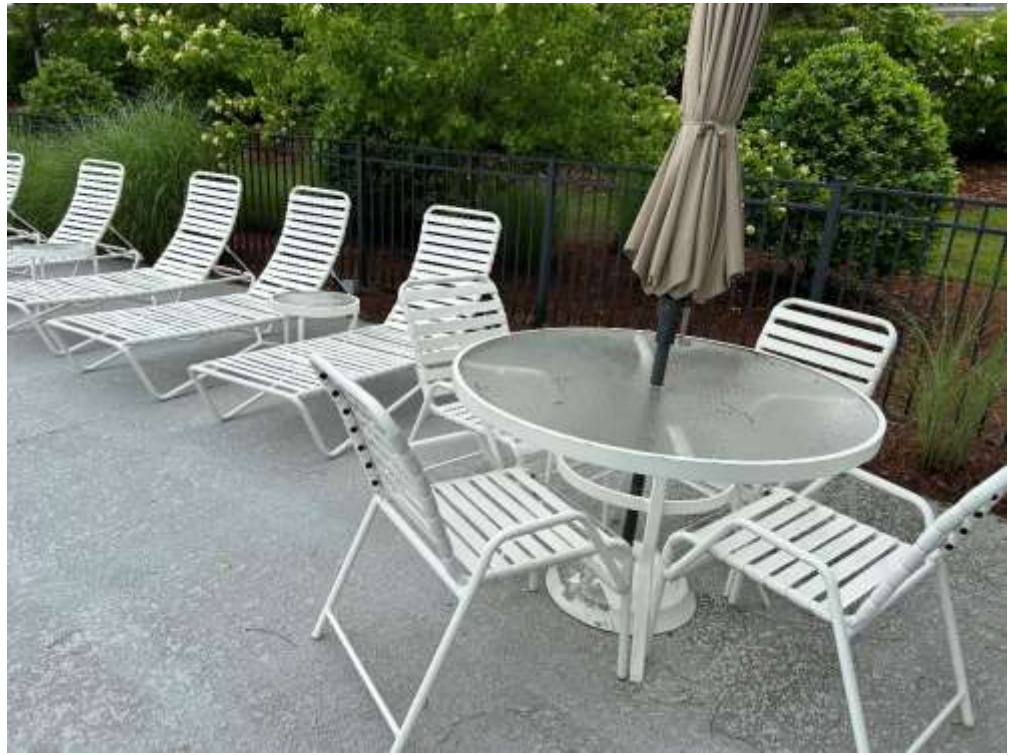
Photo No.
33

Pool furnishings

Pool and outdoor furniture consisted of aluminum frame, vinyl strapped chaise lounges and chairs, tables, umbrellas and a gas grill. Due to the unpredictability of the lifespan of these items, we have budgeted for replacement of approximately 1/3rd of the pool furniture every 3 years, beginning in 2025.

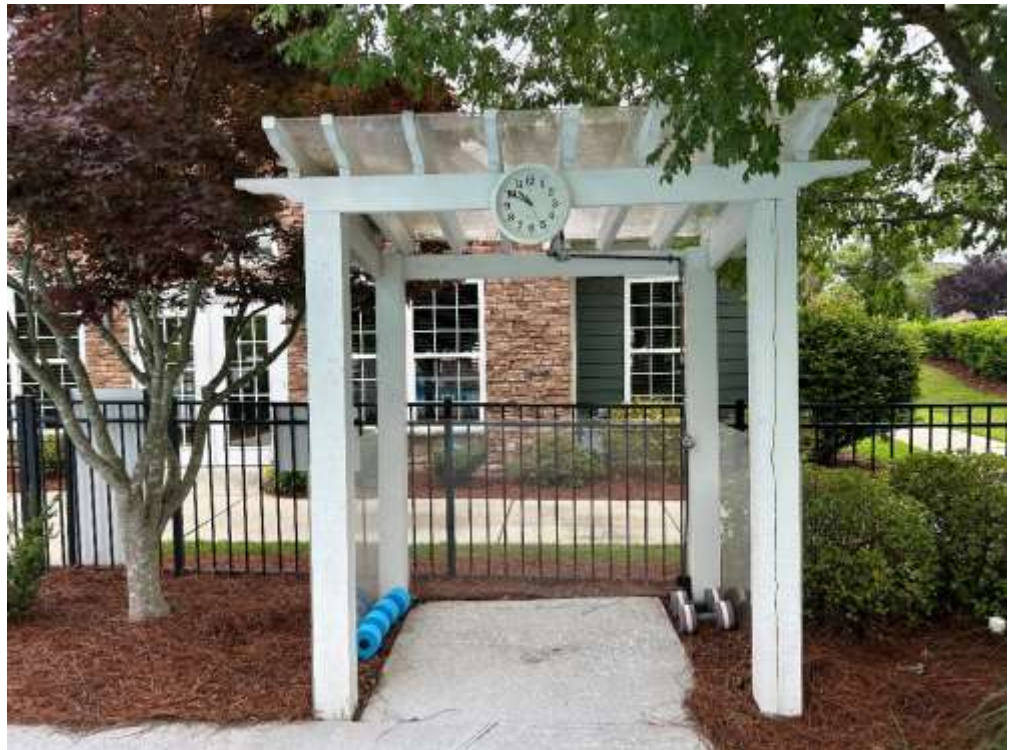
Photo No.
34

Pergola structure at pool deck
