**OLDE RALEIGH VILLAS
CONDOS
RALEIGH, NC**

**DATE:
FEBRUARY 18, 2025**

**RESERVE STUDY
UPDATE with Site
Inspection**

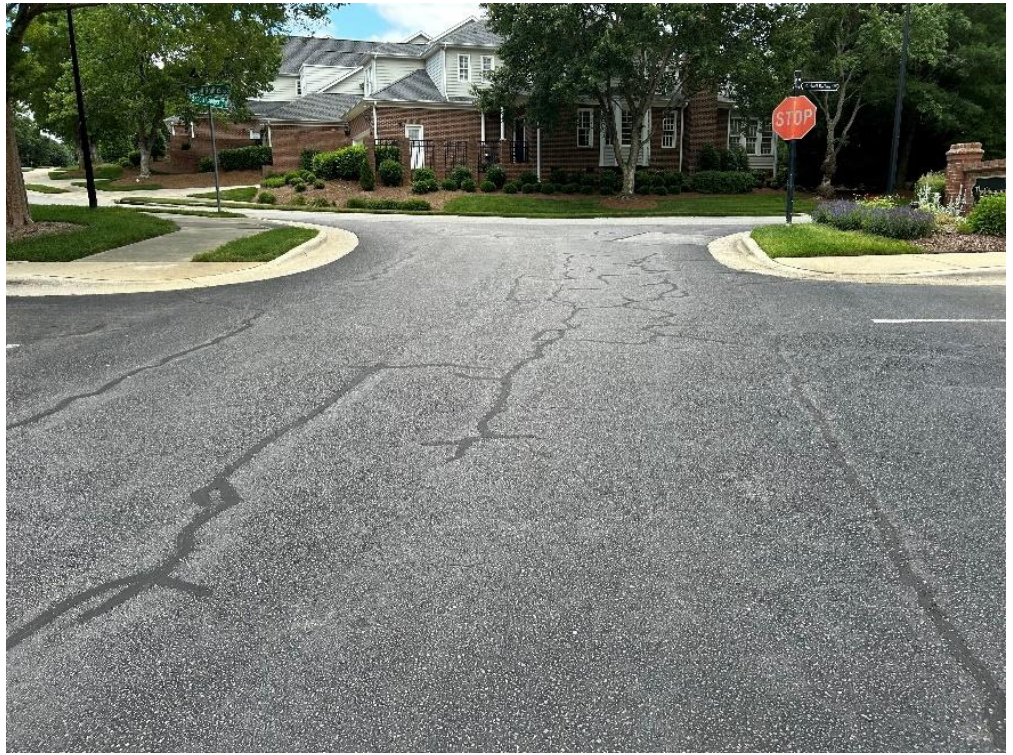
Photo No.
1

Baron Cooper Pass incorporates parking areas and an access drive leading to the parking garage entrances to each building. The asphalt paved street and parking areas generally appeared to be in good to fair condition, with minor longitudinal and fatigue cracking noted. Typically, we recommend the application of an oil resistant sealant to all asphalt paved surfaces on an approximate 5- to 8-year cycle. At this same time, all cracks should be properly filled, patched, and sealed. We have allocated funds for crack repairs and to seal the pavement every 5 years, beginning in 2026.

Minor longitudinal
cracking in asphalt
paving

Assuming seal coating and crack repairs are performed in the interim, we anticipate the asphalt paving to have an estimated useful life of approximately twenty to twenty-five years prior to full resurfacing. We have allocated funds to resurface asphalt paving in 2034. Resurfacing would include milling limited areas around curb and gutter to maintain an adequate drainage profile, repairing areas of fatigue cracking/upheaval as needed and installing a new 1.5” to 2” thick layer of asphalt pavement over the existing paved areas.

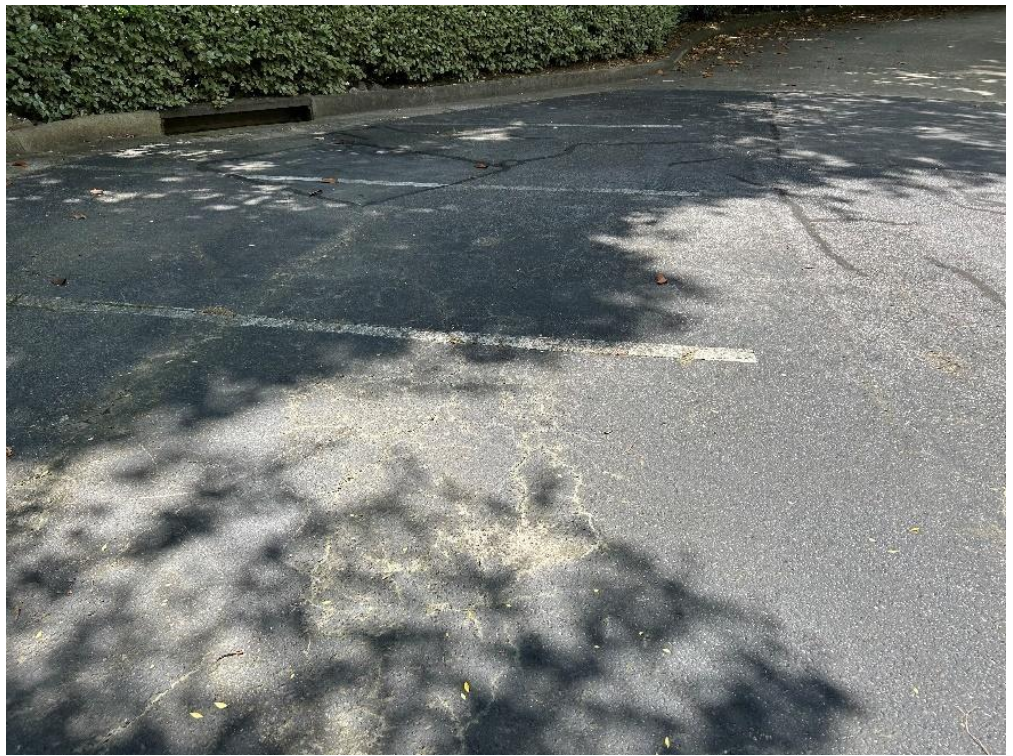
Photo No.
2

Minor fatigue cracking
and faded striping in
asphalt parking area

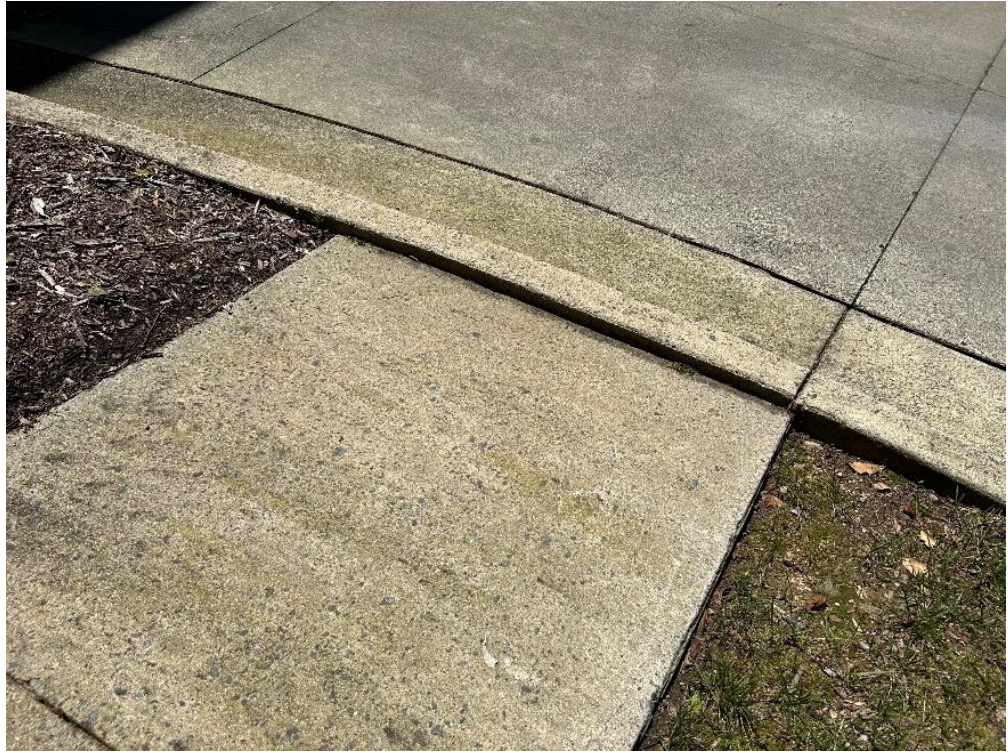
Photo No.
3

Settled concrete sidewalk (trip hazard) outside 3701

Flatwork in the community includes concrete sidewalks in the common areas and concrete drive slabs extending from the asphalt pavement into the parking garages. The parking garages are comprised of concrete pavement. The concrete access drive leading to the Building 3701 garage entrance is in poor condition, with severe scaling/spalling resulting in a deteriorating surface. We also observed some areas of settled and upheaved concrete sidewalk, some of which are trip hazards. We have allocated funds to repairs approximately 5% of the concrete flatwork on an 8-year cycle beginning in 2025.

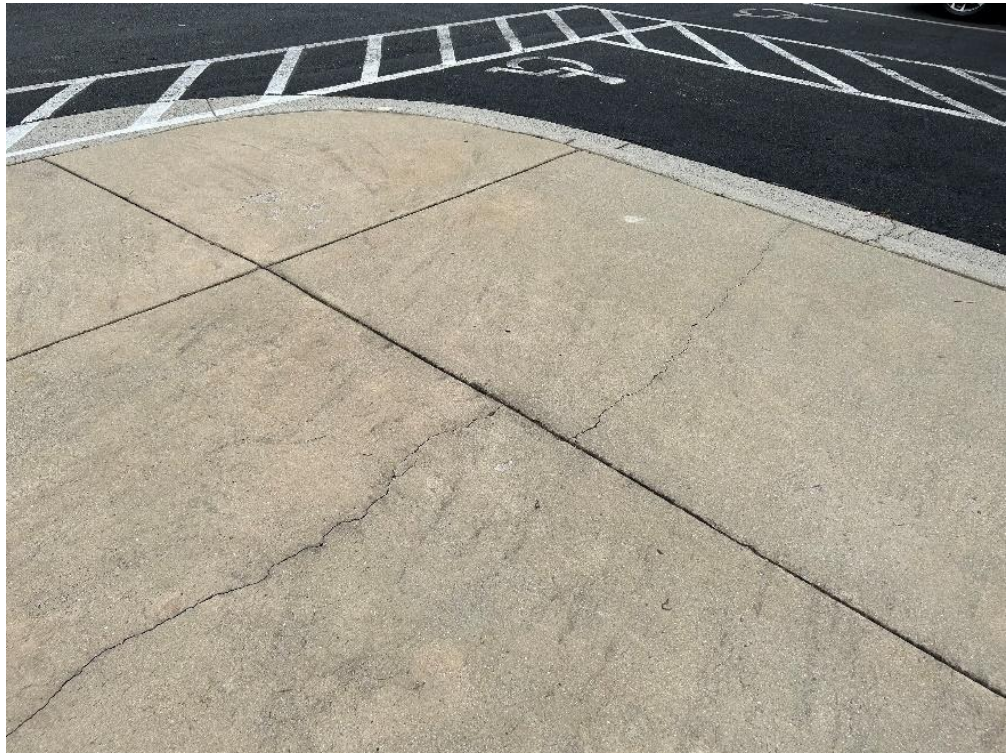
Photo No.
4

Minor cracking in concrete flatwork

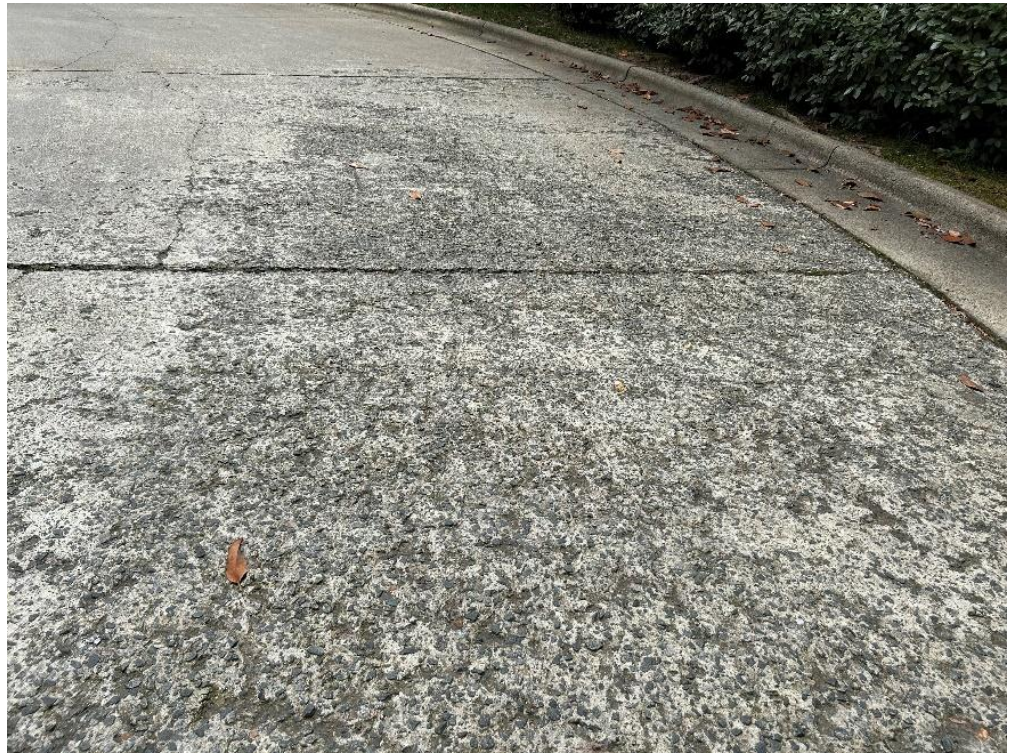
Photo No.
5

Deterioration in concrete flatwork

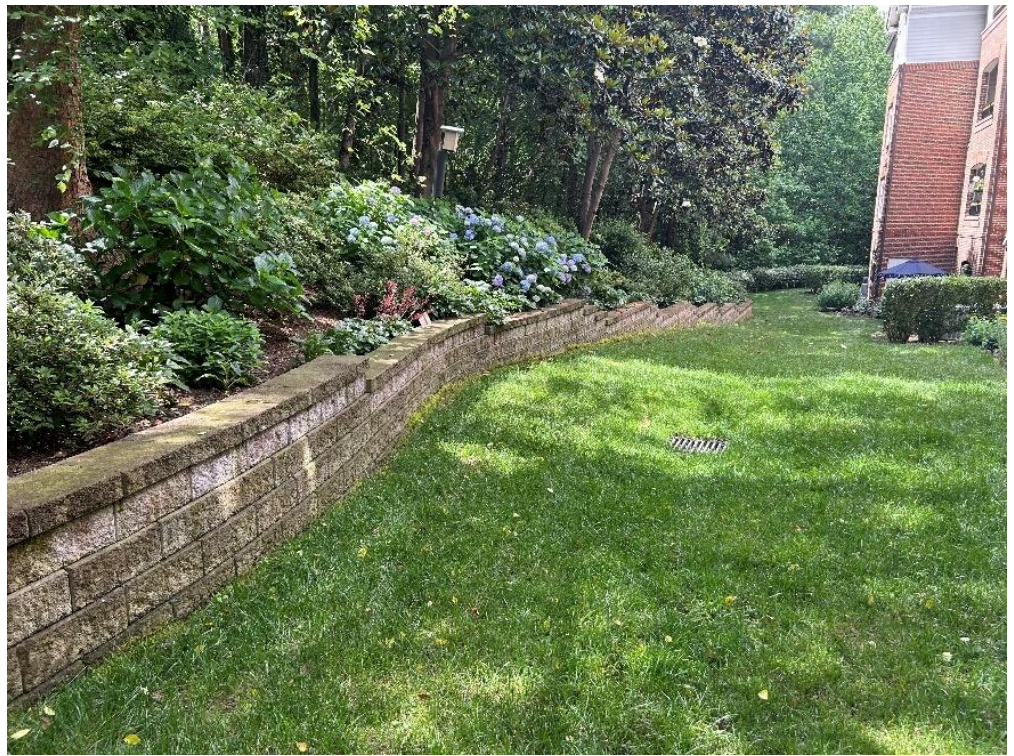
Photo No.
6

Drainage systems include inlet grates and catch basins in the paved and landscaped areas and roof downspouts are connected to buried plastic piping. The stormwater is routed to underground stormwater piping which discharges into the city storm sewer system. Per the board, saturated soil has been observed behind the 3701 Building after significant rain events. We have allocated funds to repair the drainage systems on a 5-year cycle beginning in 2025. Repairs will likely include repairing underground stormwater piping, limited retrenching of swales, installing a french drain or other types of drainage improvement systems.

Site drainage at the rear of 3701

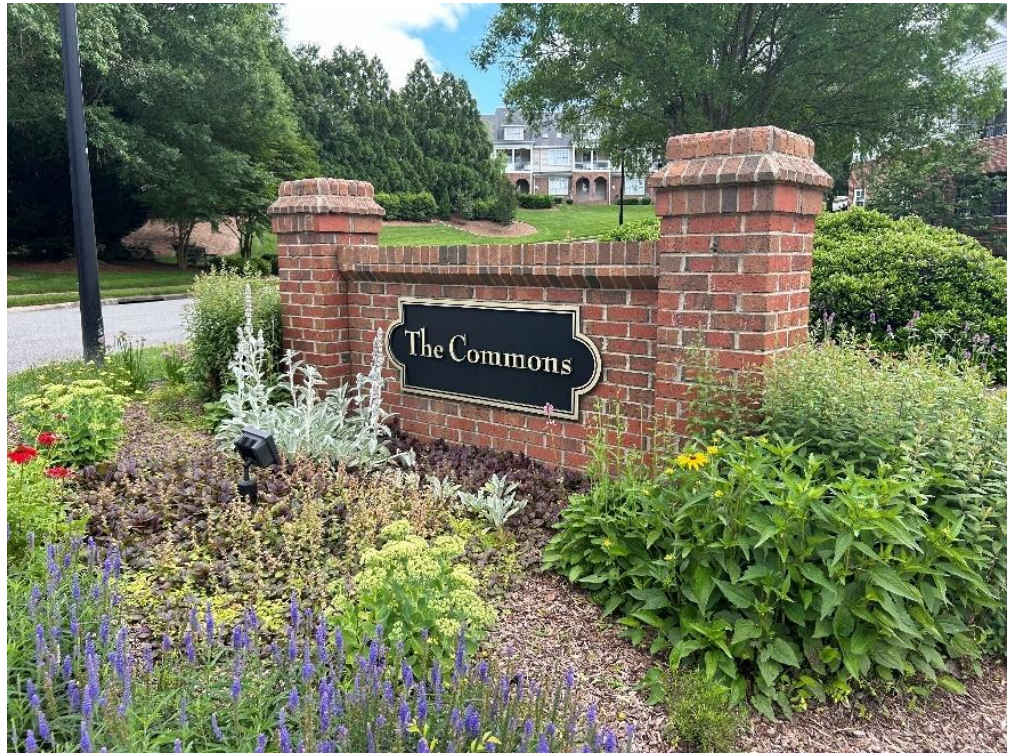
Photo No.
7

The main entrance to the community includes a brick masonry monument with composite signage on each side bearing the name of the community. The monument includes landscape uplighting. The monument appeared in generally good condition; however, the signage was aged and a portion had partially detached from the monument. We have included funds to refurbish the entrance monument and replace both composite signs in 2026. We have assumed any minor repairs, such as repointing of brick mortar, would be funded through the annual maintenance budget.

General view of the
entrance monument

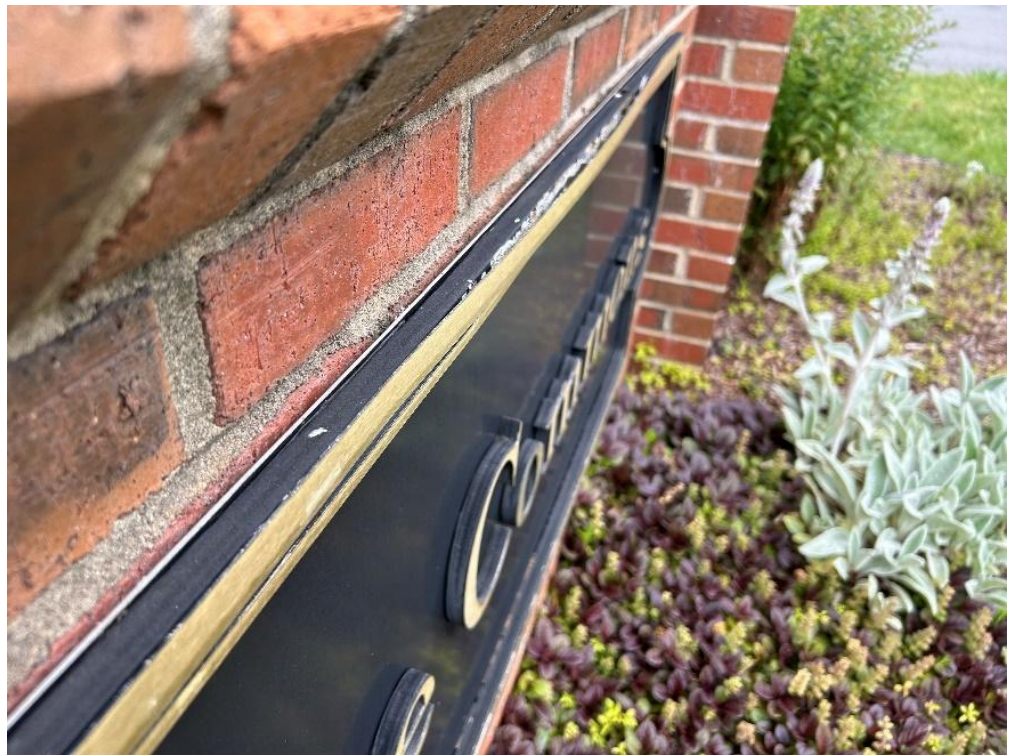
Photo No.
8

Trim falling off
composite site

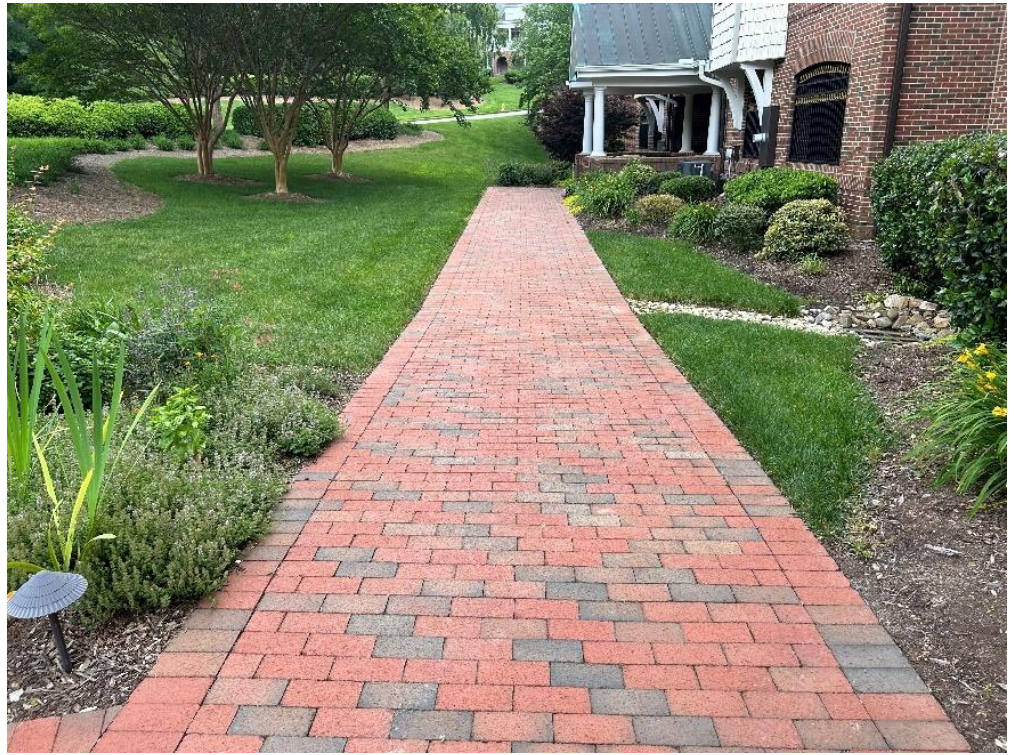
Photo No.
9

There is a brick walkway that leads from the parking area to the entrance to the 3701 building and brick just outside the entrance to the 3700 building. The walkways appeared to be in good condition and we have included funds to repair them as needed on an 8-year cycle beginning in 2030.

Brick walkway leading to 3701

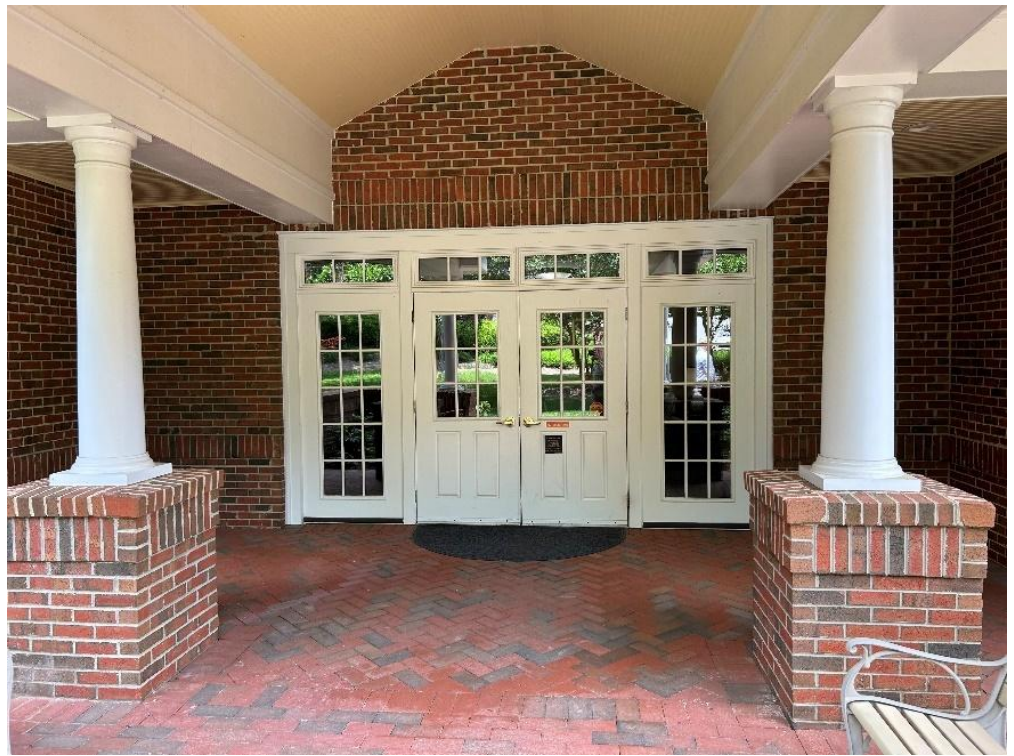
Photo No.
10

The front of each building includes fiberglass skin doors. Each entrance includes two doors, two inoperable fixed doors, and four transom windows. We have allocated funds to replace these doors on a 30-year cycle beginning in 2035.

General view of building front door and cover

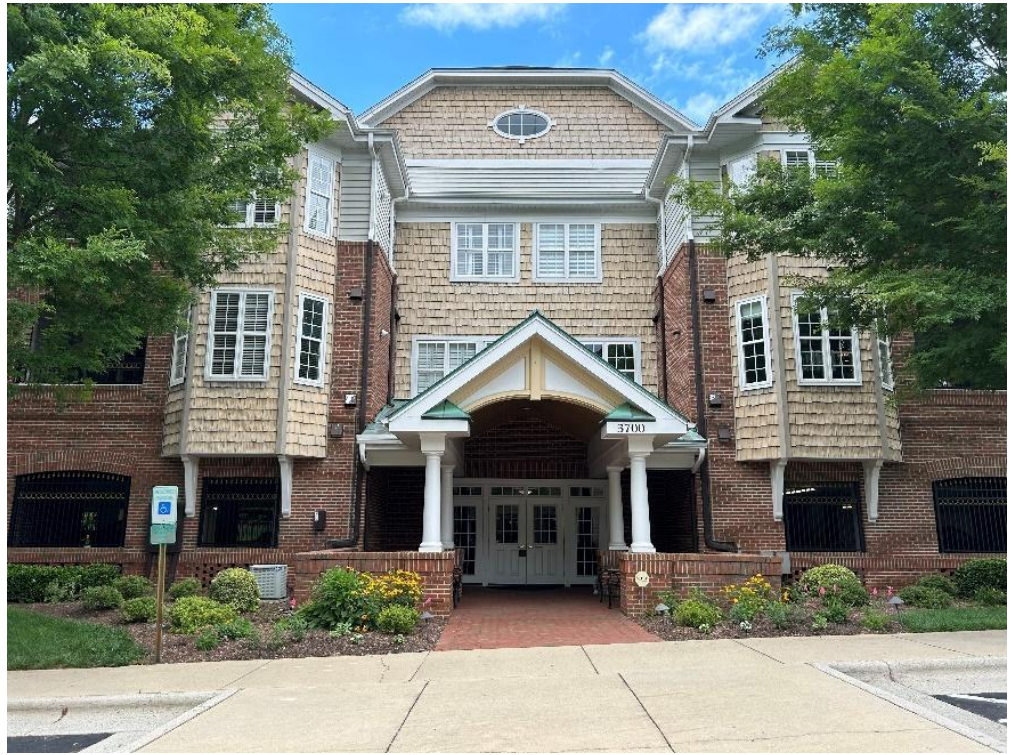
Photo No.
11

The brick veneer and vinyl siding generally appear to be in good to fair condition, with fading noted on the vinyl siding, and we do not anticipate that significant repairs will be required over the term of this study. The limited areas of wood and paintable surfaces on the exterior of each building will require minor repairs and repainting. We have allocated funds to caulk, repair and paint the exterior surfaces and doorframes every 7 years beginning in 2027. This also includes funds to replace vertical sealant/caulking in building joints and sealant/caulking around windows. Note that minor spot painting should be funded from the annual maintenance budget.

General view of building entry with vinyl siding and painted trim components

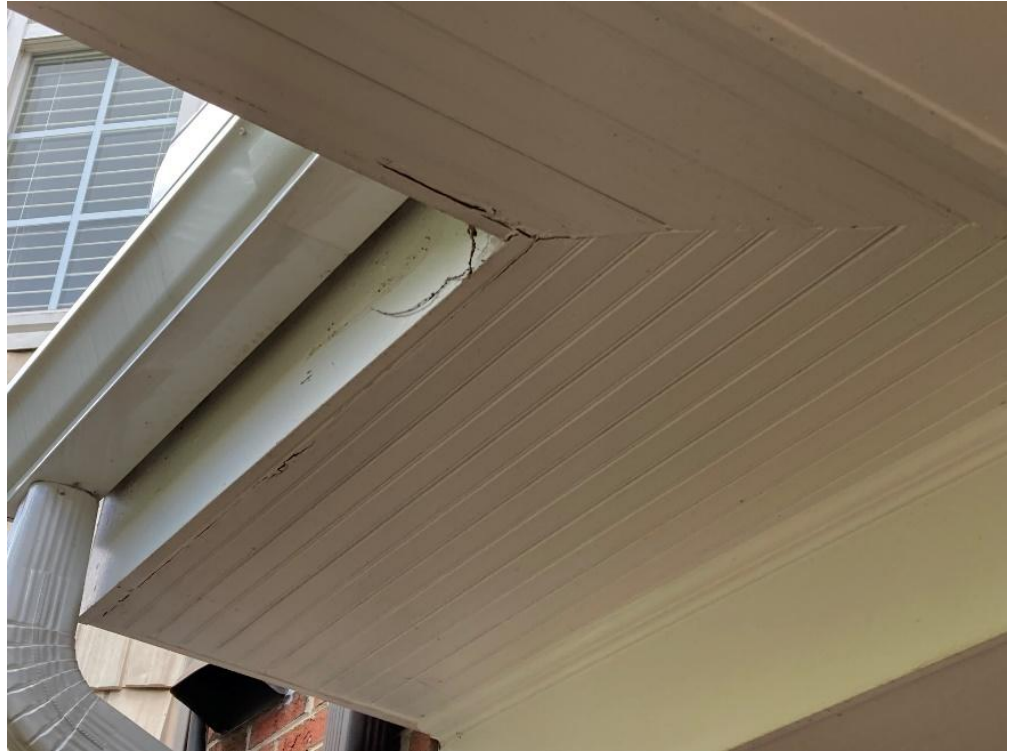
Photo No.
13

Painted trim components showing deterioration

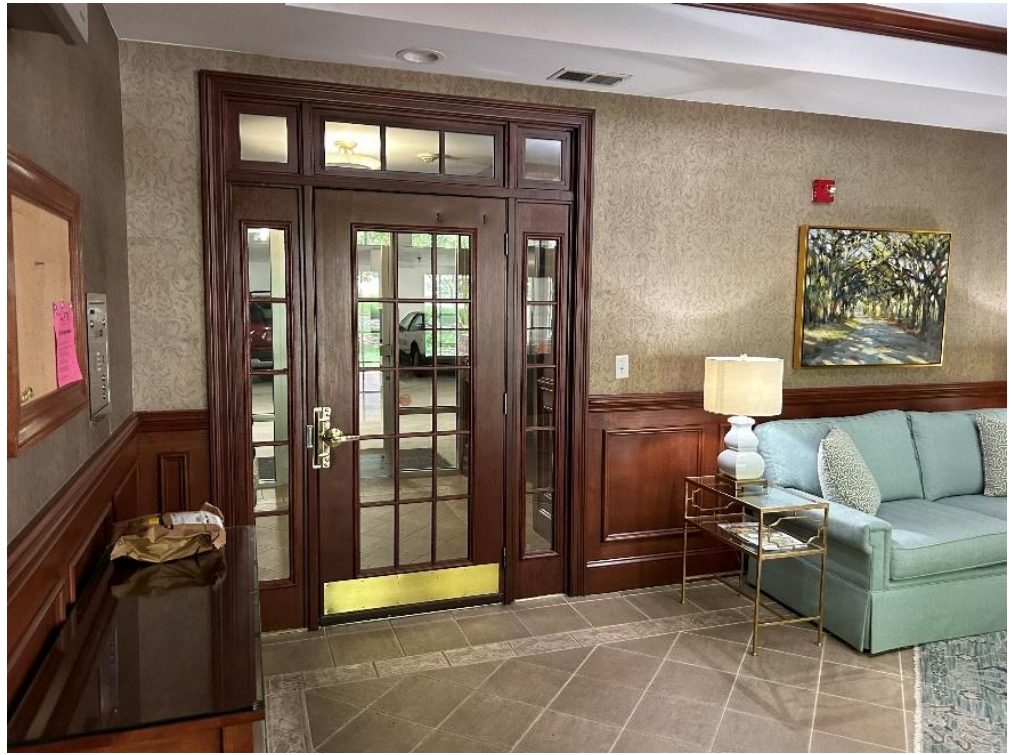
Photo No.
21

The flooring of the interior corridors and stairwell areas is covered in carpet. A limited area of the entrance lobbies is covered in ceramic tile. Although the corridor carpeting has never been replaced in either building the carpeting appeared to be in relatively good condition. We were advised that the installed carpet was a very high quality and the use of the corridors is not subject to high wear rates. The carpeting in the stairwells was also in relatively good condition. We have allocated funds to replace the carpeting in the corridors on a 15-year cycle beginning in 2027 (Bldg. 3701) and 2029 (Bldg. 3700) and in the stairwells in 2033 (Bldg. 3701) and 2035 (Bldg. 3700). We have also included funds to replace the ceramic tile flooring in both buildings every 25 years beginning in 2030.

Tile flooring in lobby
and outside elevator

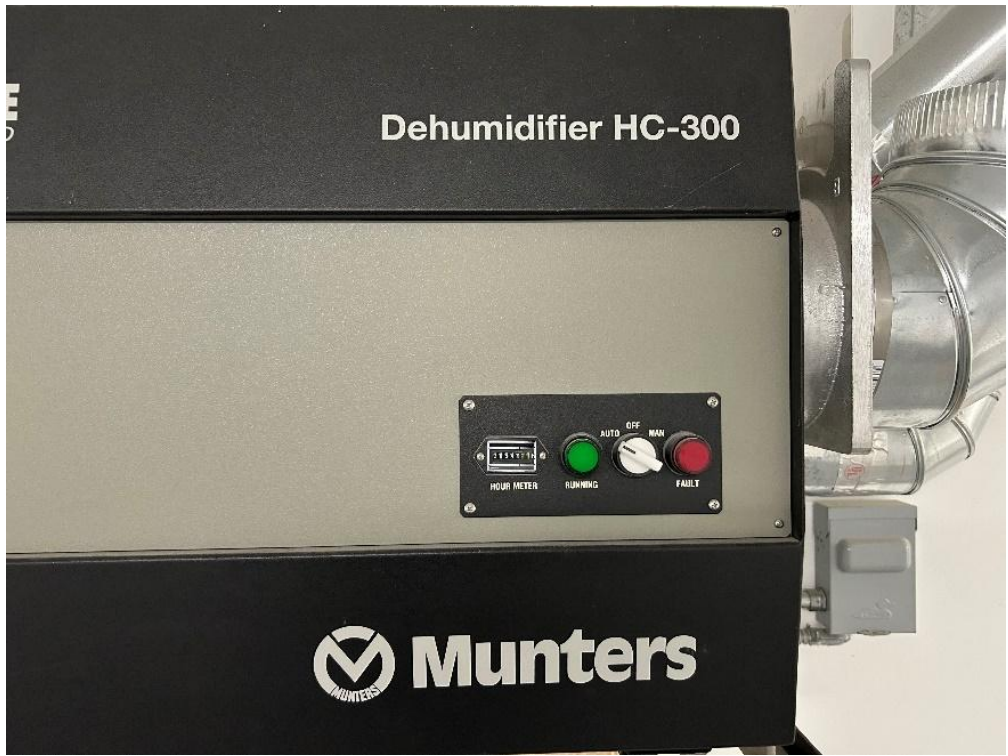
Photo No.
30

A Munters HC-300 commercial dehumidifier has been installed in the owner storage room area of each building. These dehumidifiers reduce humidity levels in most storage rooms; however, it was previously noted that one unit required a small residential dehumidifier to better control humidity and mold within the single storage unit. We have assumed that the addition of any small dehumidifiers to any of the individual storage units would be funded from an annual maintenance budget. We have included funds to replace the large Munters dehumidifiers on a 15-year cycle beginning in 2029 (Bldg. 3701) and 2030 (Bldg. 3700).

Description
Storage room dehumidifier
